# 2002 Annual Compliance Report Slick Rock, Colorado, Disposal Site

## Compliance Summary

Figure 17-1. 2002 Annual Compliance Drawing for the Slick Rock, Colorado, Disposal Site

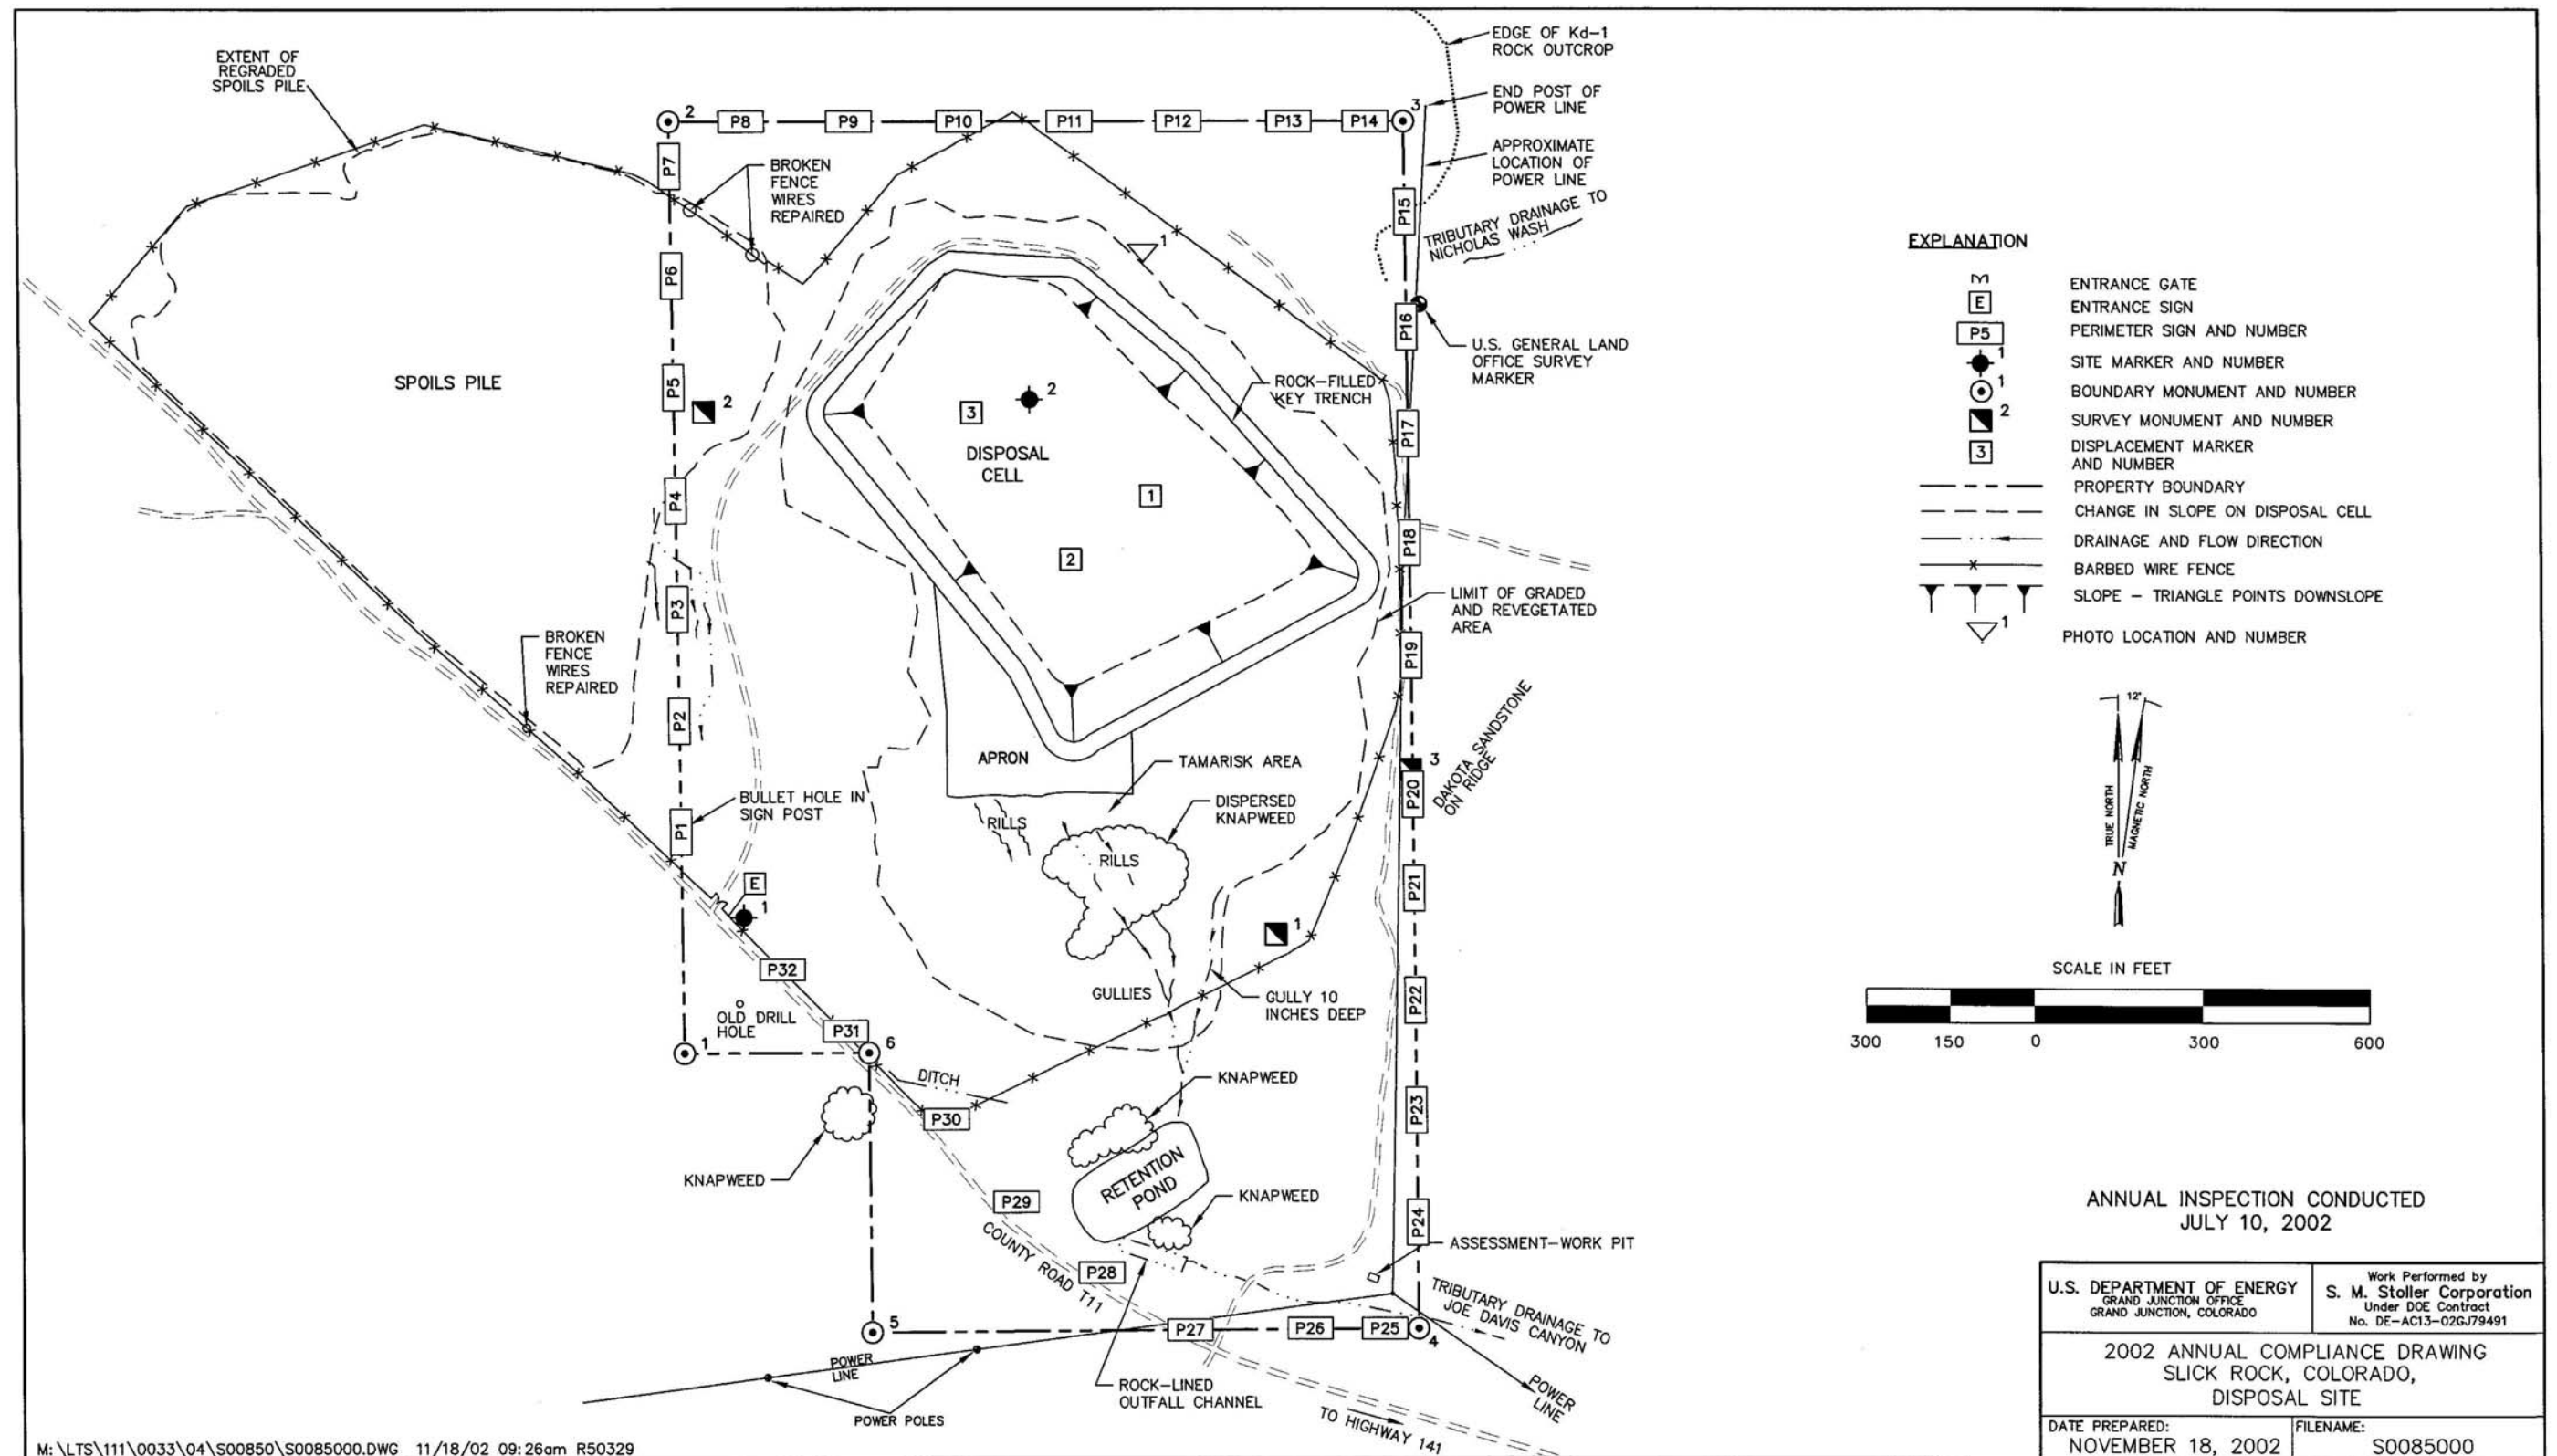
As noted during previous inspections, rills and a few gullies are present downslope from the disposal cell apron (between the apron and retention pond) and along the western boundary between perimeter signs P2 and P4. The rills appear to be healing slowly, as indicated by the rounded edges and establishment of vegetation in the bottom of the rills. These erosional features should continue to be monitored.

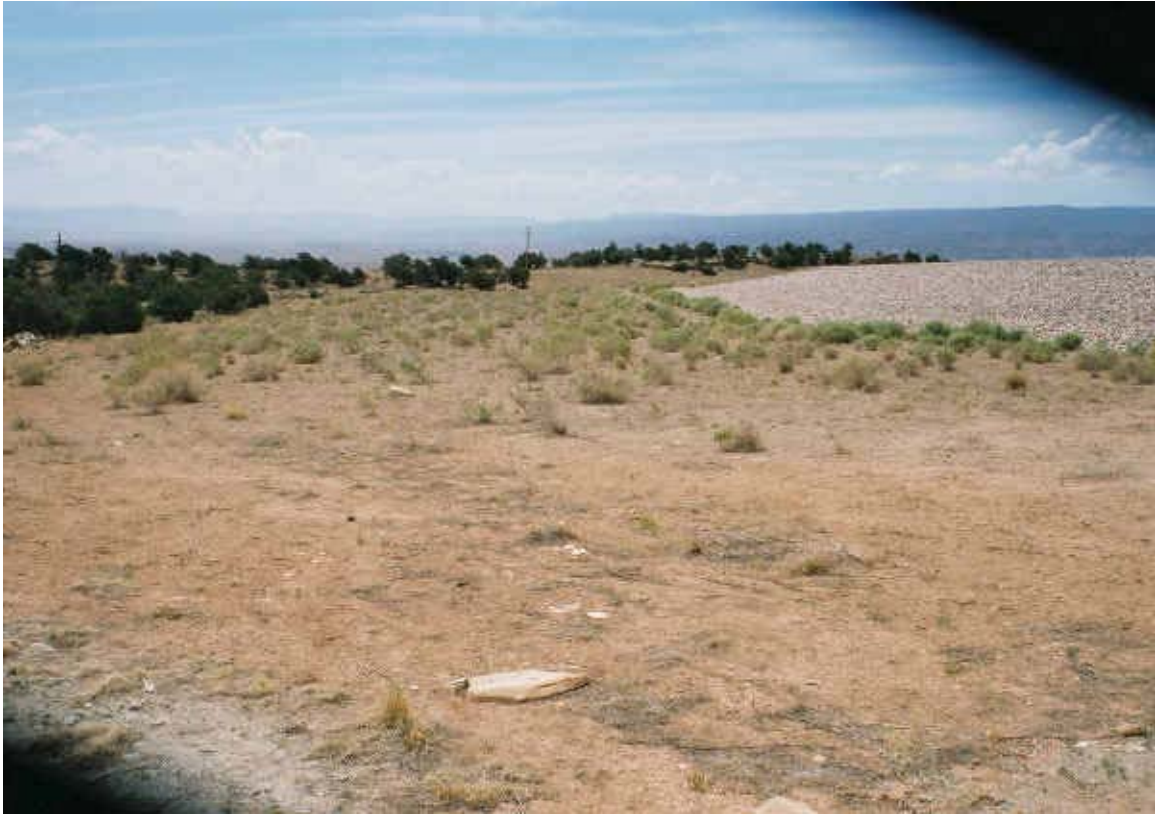
Disturbed areas around the disposal cell are primarily on the western, southern, and northeastern sides of the cell. These areas were graded and seeded in 1996 and seeded again in March 1999. Reseeded areas had approximately 20 percent cover by four-wing saltbush and, on the north, west, and southwest portions, an understory of Russian thistle and cheatgrass. The east and southeast portions of the reseeded area had an understory of more desirable perennial species. Photograph PL-1 shows vegetative cover on the northeast side of the cell.

*PL-1. Revegetated area on northeast side of cell.*
